**Flood Control Project Maintenance
Levee Inspections**

Fall 2018 Levee Maintenance Deficiency Summary Report

San Joaquin River Basin

**Flood Control Project Maintenance
Levee Inspections****LMA District Cover Sheet****Fall 2018 Levee Inspection Results****Reclamation District No. 0524 Middle Roberts Island**

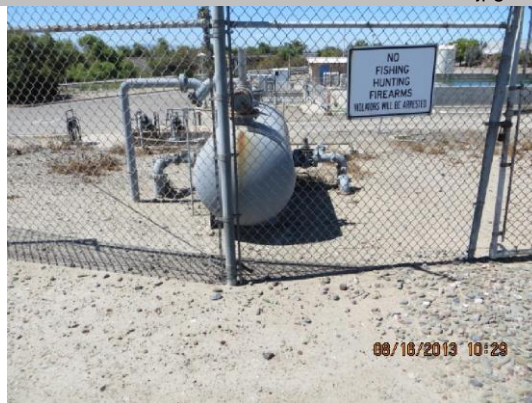
Photo 2 of 3 : UCIP_FA_2018_17563_29701.jpg

Siphon Priming tank and associated pipes on LS shoulder.

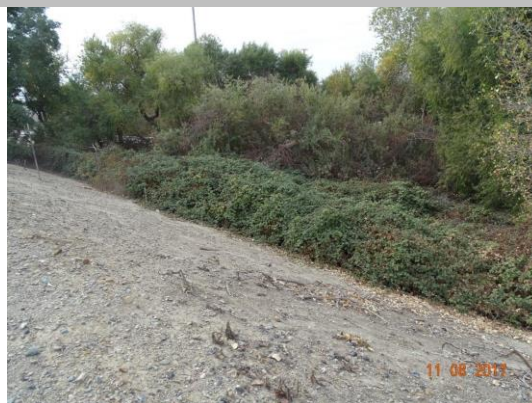
Photo 1 of 3 : FA_2018_RD0524_107_262_20180906_00347.jpg

Looking northeast at the landside slope.

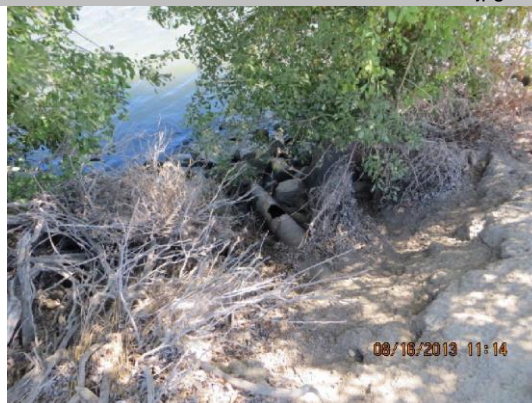
Photo 2 of 2 : UCIP_FA_2018_17571_29718.jpg

Large hole in pipe at WS toe.

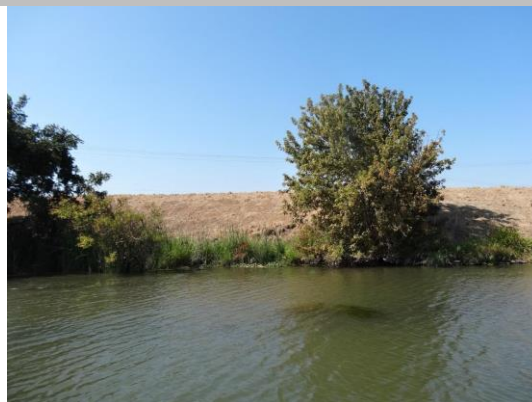
Photo 1 of 2 : FA_2018_RD0524_107_22_20180906_00040.jpg

Front view of the erosion. The tree and vegetation block the view of the site.

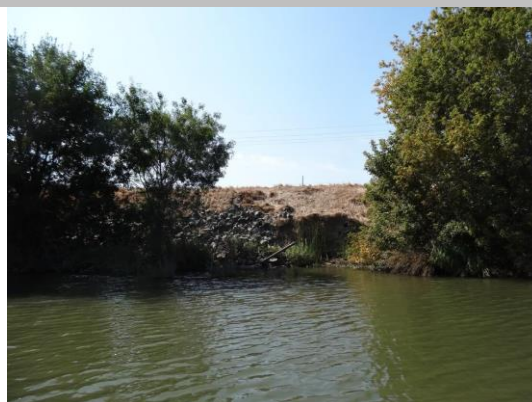
Photo 2 of 3 : FA_2018_RD0524_107_29_20180906_00051.jpg

Close view of the erosion.

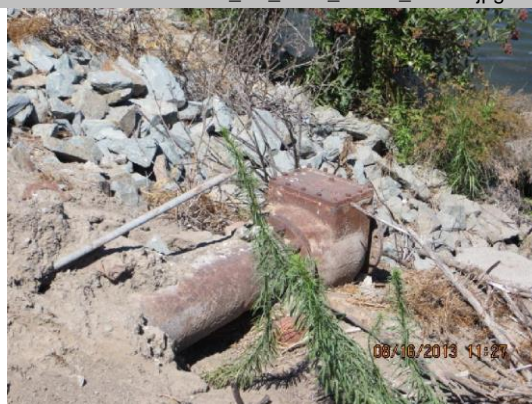
Photo 2 of 3 : UCIP_FA_2018_22724_38441.jpg

Pipe visible on WS slope.

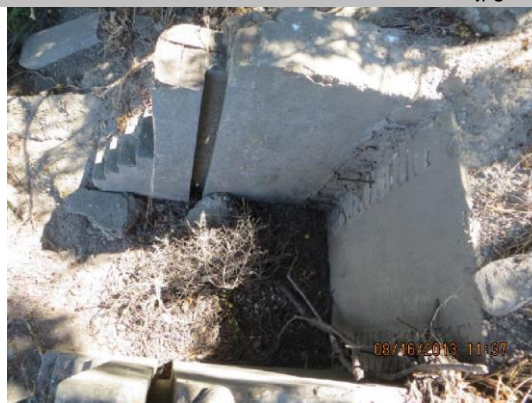
Photo 2 of 2 : UCIP_FA_2018_17575_29735.jpg

Slide gate removed from headwall on WS slope.

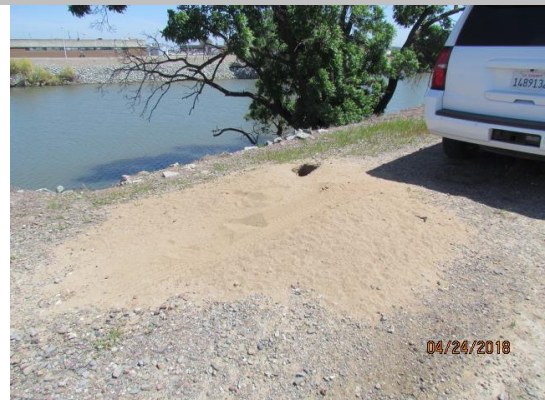
Photo 3 of 3 : FA_2018_RD0524_107_150_20180906_00193.jpg

Looking southeast at large rodent hole on waterward shoulder. (Spring 2018)

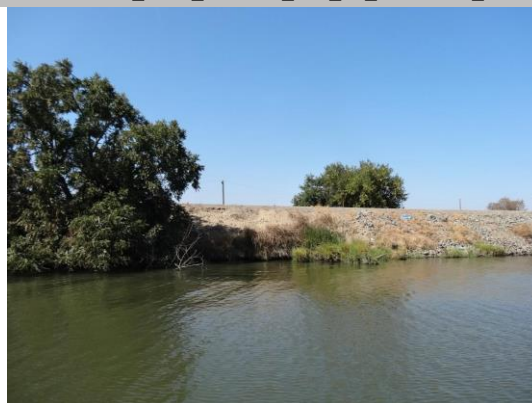
Photo 4 of 4 : FA_2018_RD0524_107_44_20180906_00076.jpg

View of the site. Note the tree near the erosion site.

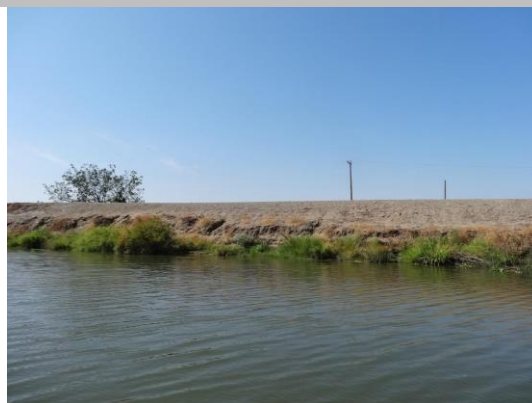
Photo 1 of 4 : FA_2018_RD0524_107_47_20180906_00084.jpg

Front view of the erosion.

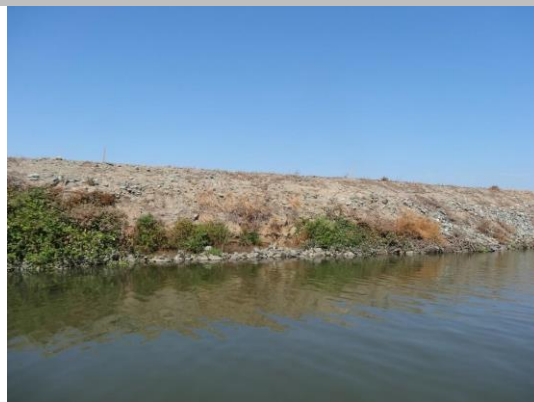
Photo 4 of 4 : FA_2018_RD0524_107_60_20180906_00109.jpg

Close view of the erosion.

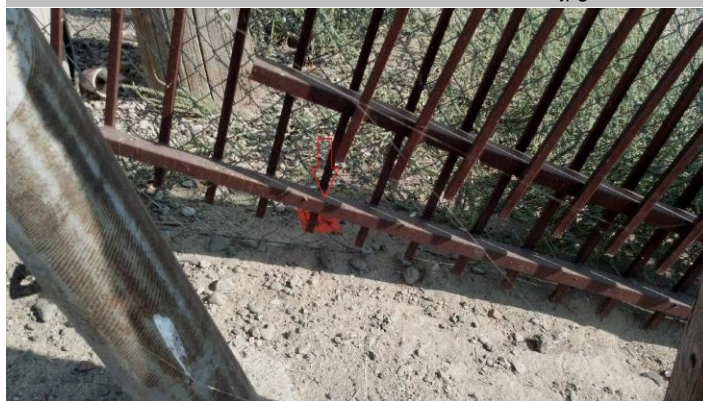
Photo 1 of 2 : UCIP_FA_2018_17798_29935.jpg

USAA markers along alignment at gate.

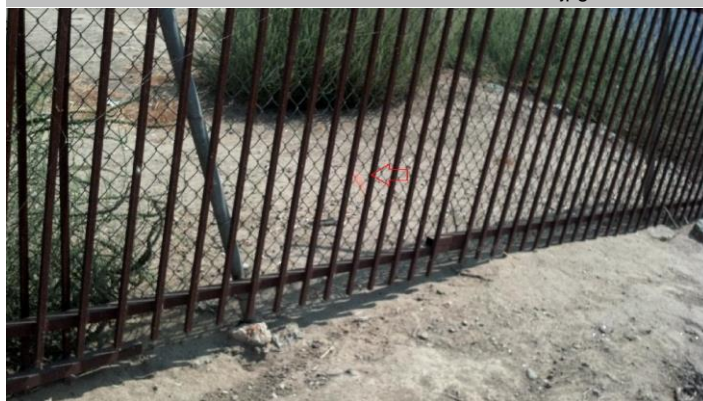
Photo 2 of 2 : UCIP_FA_2018_17798_29934.jpg

USAA markers along alignment at gate.

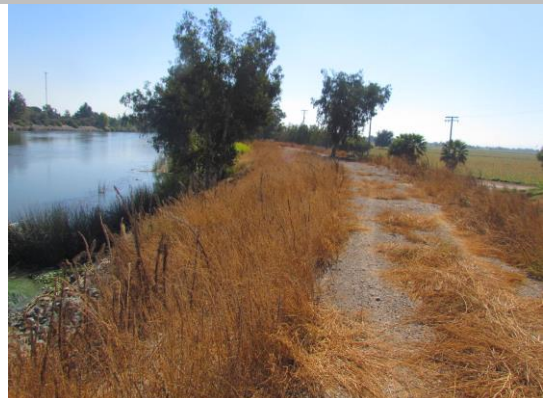
Photo 3 of 3 : FA_2018_RD0524_107_25_20180906_00044.jpg

Looking southwest at dense veg on waterward slope.

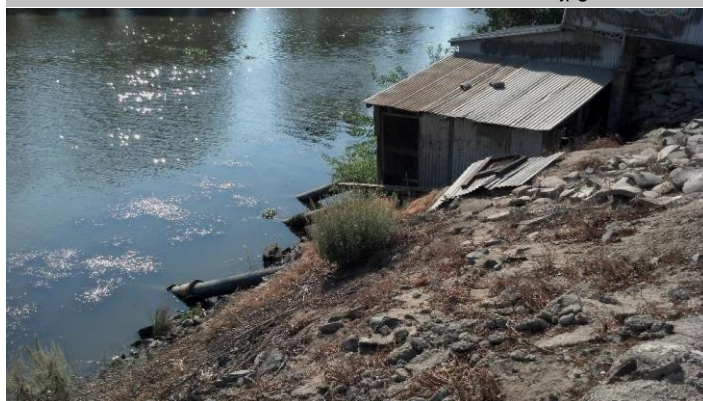
Photo 1 of 3 : UCIP_FA_2018_21866_37124.jpg

Pipe visible at lower left.

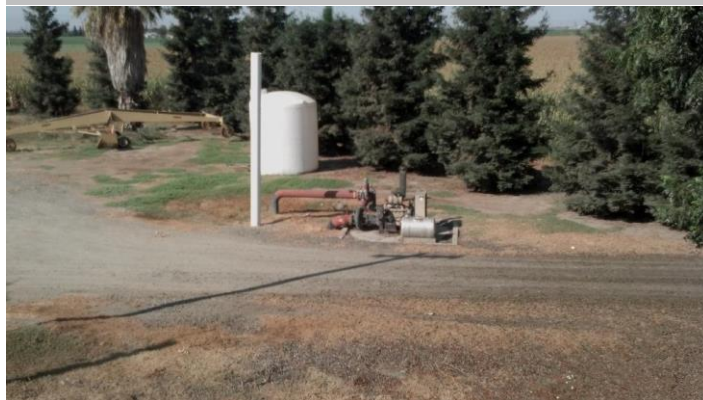
Photo 2 of 3 : UCIP_FA_2018_21866_37123.jpg

Pumping plant off LS toe.

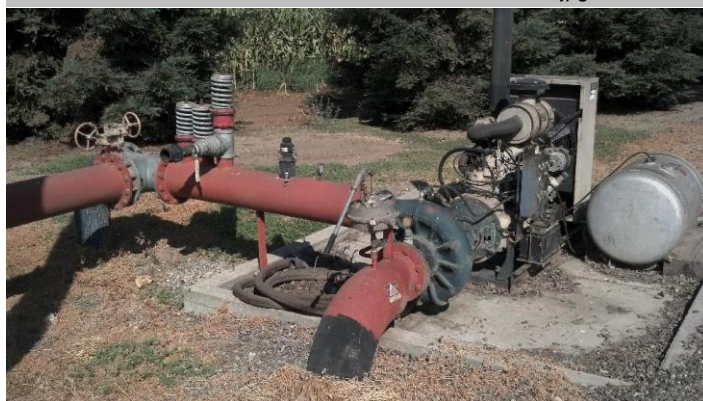
Photo 3 of 3 : UCIP_FA_2018_21866_37122.jpg

Pumping plant with siphon breaker, vents, and butterfly valves.

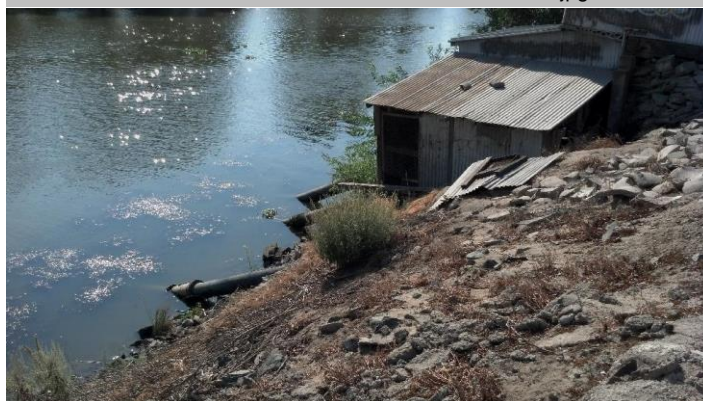
Photo 1 of 3 : UCIP_FA_2018_17847_29962.jpg

Pipes and pumphouse on WS slope.

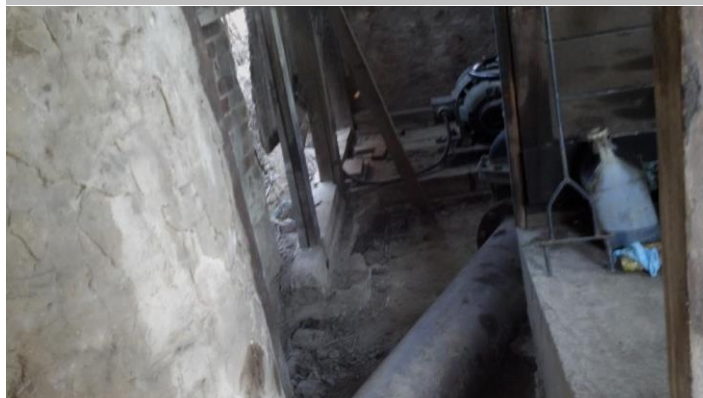
Photo 3 of 3 : UCIP_FA_2018_17847_29960.jpg

Pipes at connection to concrete surge box on WS inside pumphouse.

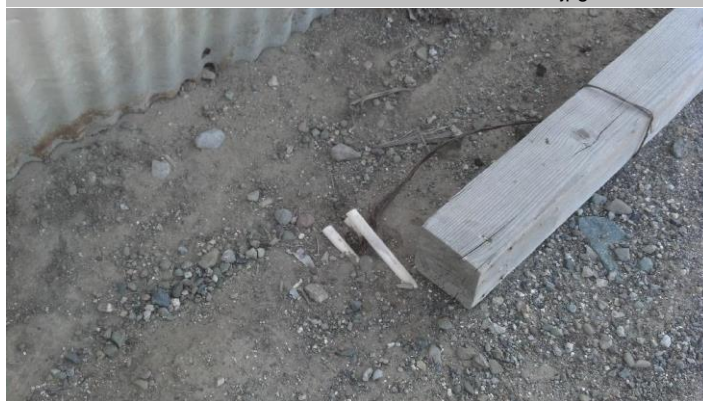
Photo 1 of 2 : UCIP_FA_2018_21865_37121.jpg

Pipes visible on WS shoulder directly in front of pumphouse.

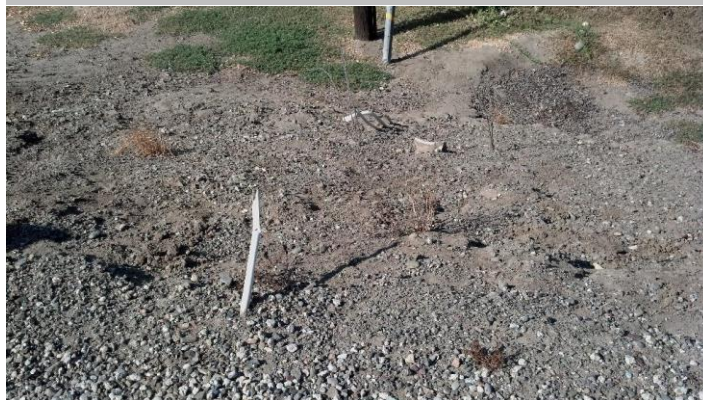
Photo 2 of 2 : UCIP_FA_2018_21865_37120.jpg

Pipes visible on LS slope.

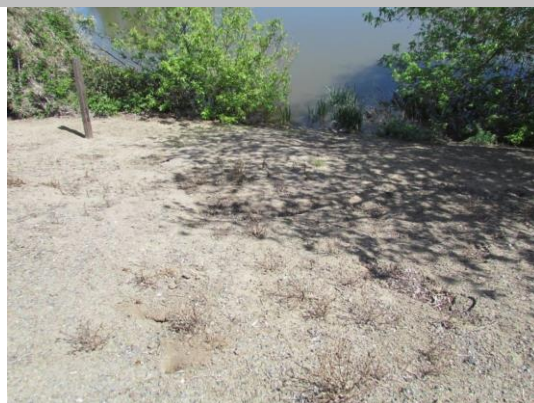
Photo 1 of 1 : FA_2018_RD0524_107_159_20180906_00212.jpg

Looking at minor cracking and sloughing on waterward slope.

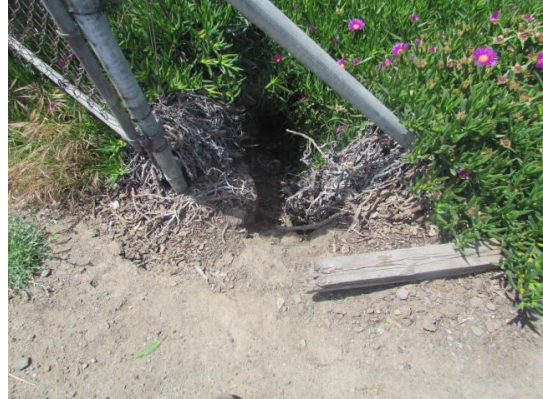
Photo 1 of 2 : FA_2018_RD0524_107_176_20180906_00231.jpg

Looking west at erosion within landscaping on landward shoulder and slope.

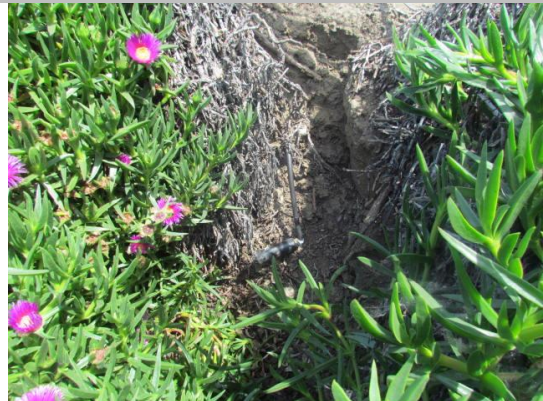
Photo 2 of 2 : FA_2018_RD0524_107_176_20180906_00232.jpg

Looking east at erosion within landscaping on landward slope and shoulder.

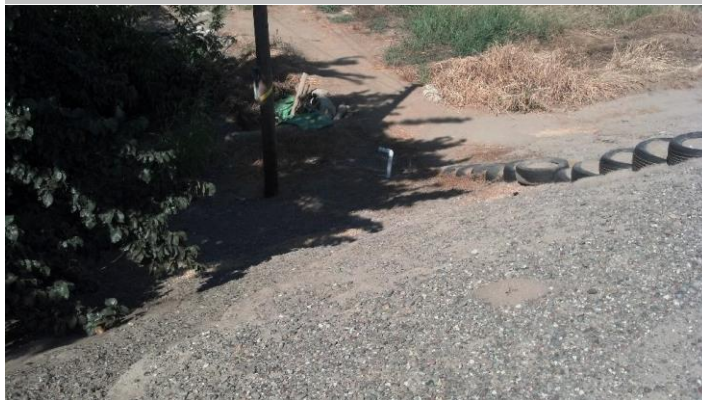
Photo 2 of 3 : UCIP_FA_2018_21872_37127.jpg

PVC pipe visible on LS toe.

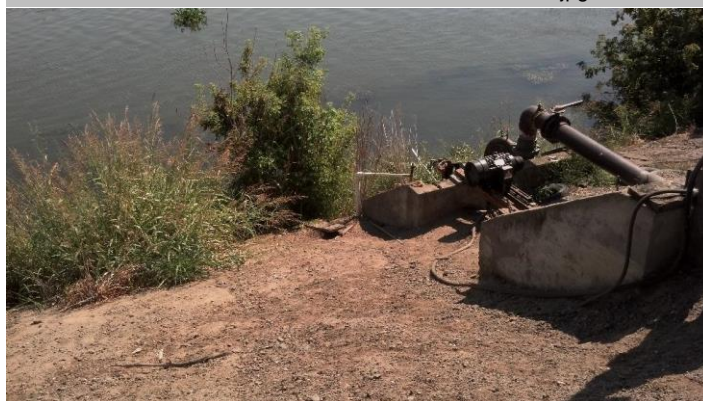
Photo 3 of 3 : UCIP_FA_2018_21872_37126.jpg

Pump and pipe visible on WS slope.

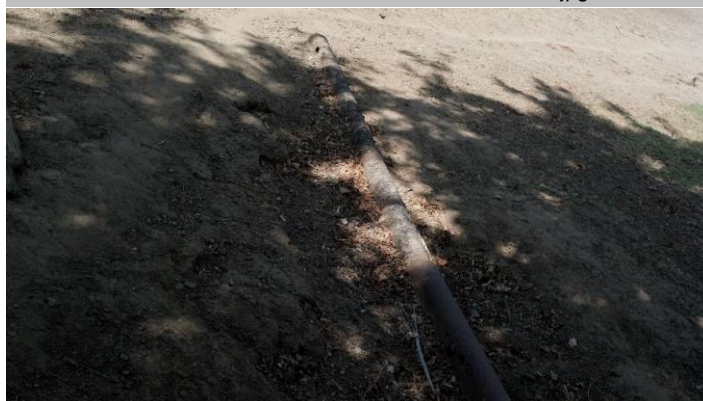
Photo 1 of 2 : UCIP_FA_2018_21883_37134.jpg

Pipe visible on WS slope.

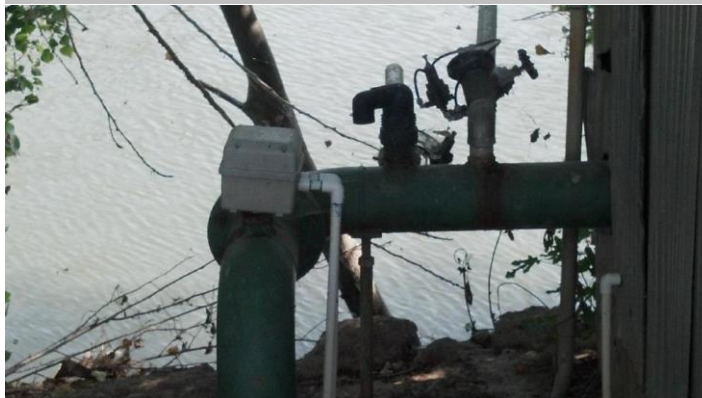
Photo 2 of 3 : UCIP_FA_2018_21895_37141.jpg

Irrigation line visible on side of pumphouse.

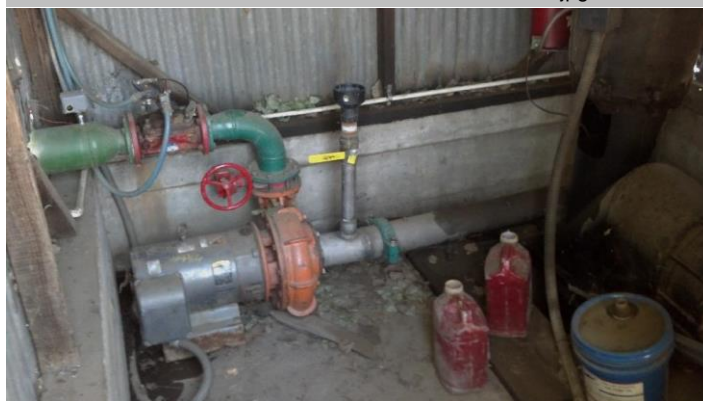
Photo 3 of 3 : UCIP_FA_2018_21895_37140.jpg

Pump and butterfly valve inside pumphouse on WS berm.

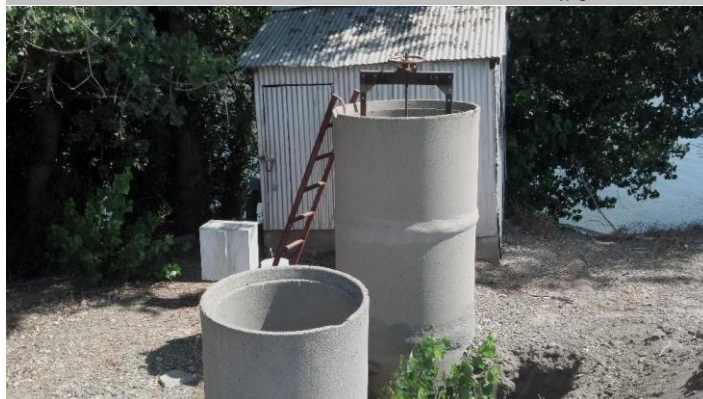
Photo 1 of 3 : UCIP_FA_2018_17944_30045.jpg

Slide gate in concrete riser with secondary concrete riser in foreground. Pump house in background.

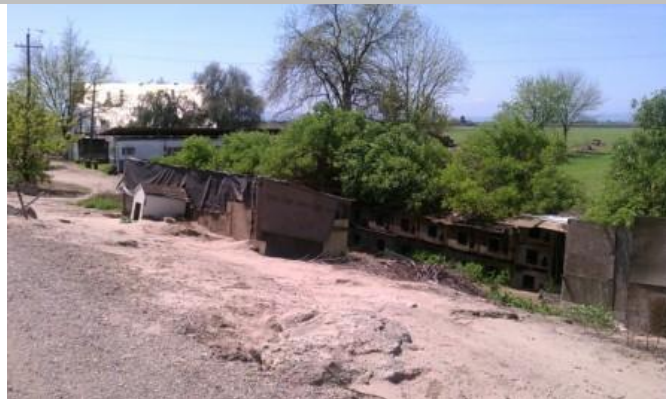
Photo 2 of 2 : FA_2018_RD0524_107_42_20180906_00071.jpg

Looking at animal pens on landside slope and toe.

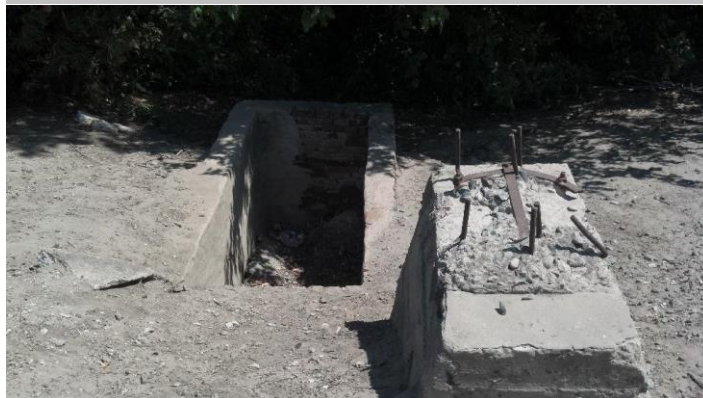
Photo 1 of 3 : UCIP_FA_2018_21935_37162.jpg

Foundation for pump with distribution box on WS shoulder.

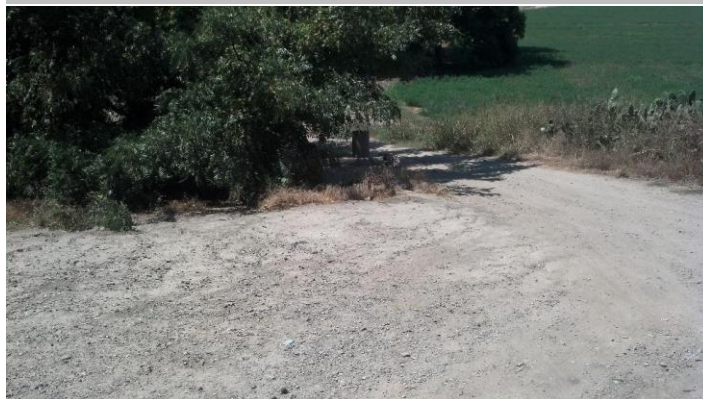
Photo 2 of 3 : UCIP_FA_2018_21935_37161.jpg

Distribution box on LS toe.

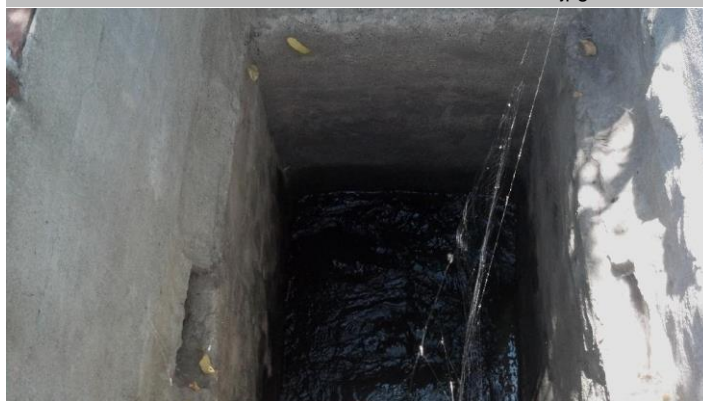
Photo 3 of 3 : UCIP_FA_2018_21935_37160.jpg

Distribution box on LS toe.

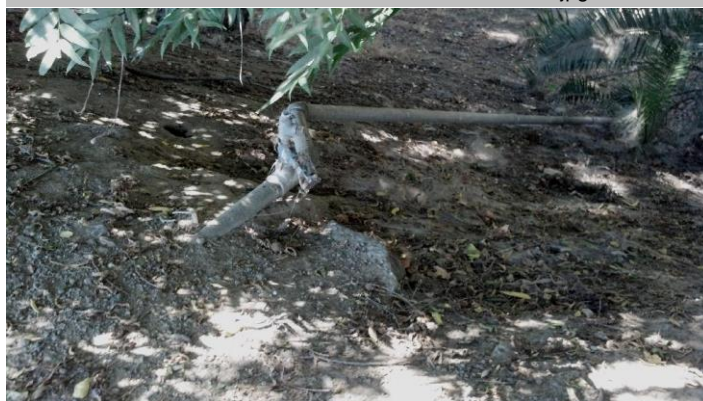
Photo 1 of 2 : UCIP_FA_2018_18085_30191.jpg

Pipe and vent visible on LS slope.

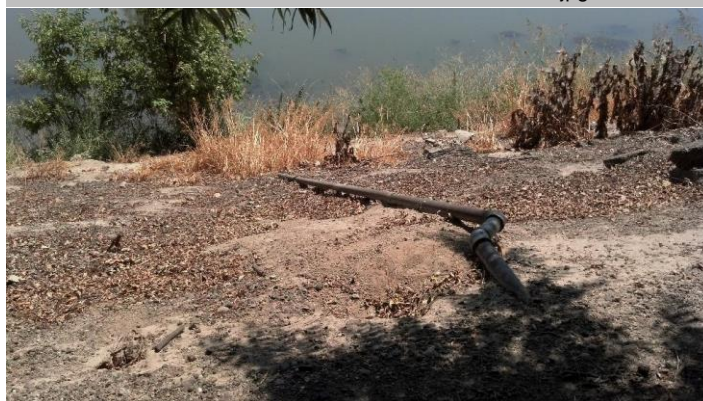
Photo 2 of 2 : UCIP_FA_2018_18085_30190.jpg

Pipe visible on WS slope.

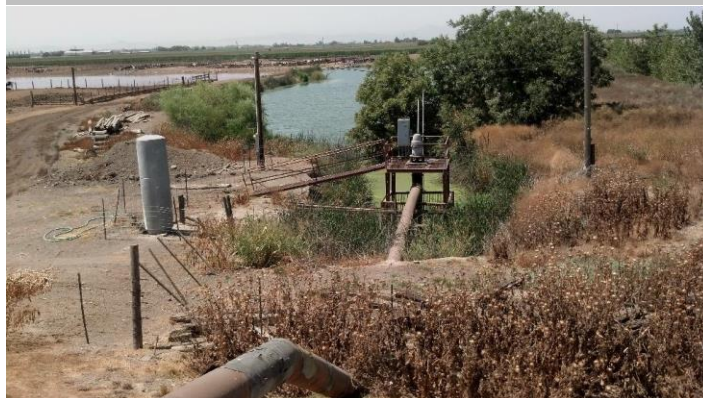
Photo 2 of 2 : UCIP_FA_2018_18089_30197.jpg

Pipe, pump, power pole, and meter visible off LS toe.

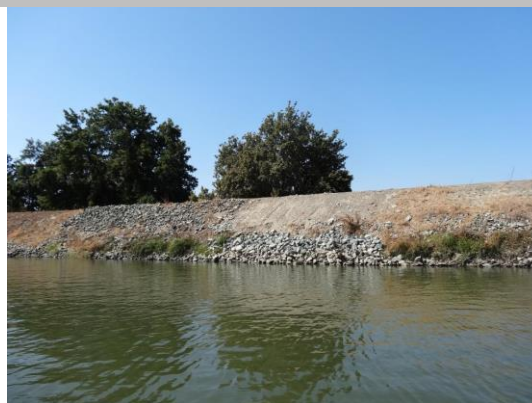
Photo 4 of 4 : FA_2018_RD0524_107_79_20180906_00139.jpg

Front View of the erosion.

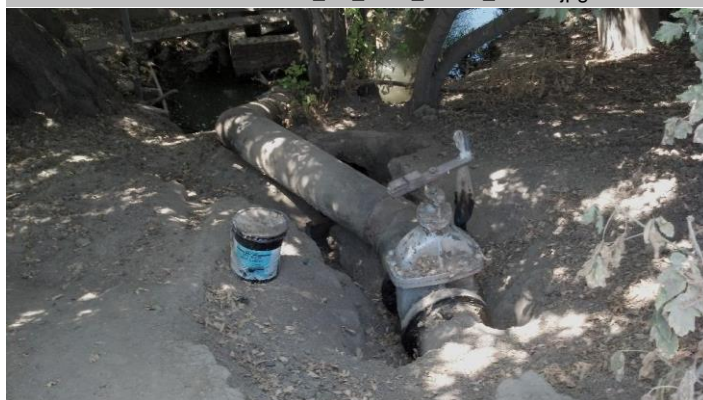
Photo 2 of 3 : UCIP_FA_2018_53357_30205.jpg

Pipe, gatevalve, and erosion on LS slope.

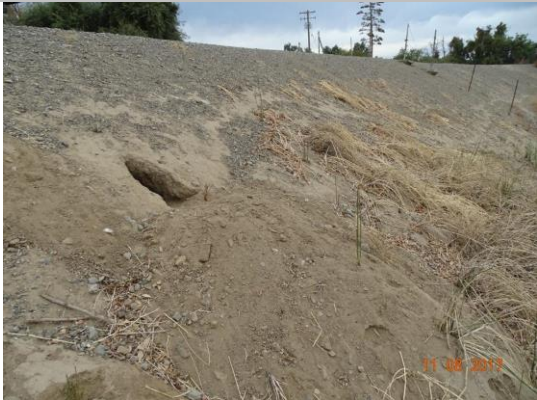
Photo 1 of 1 : FA_2018_RD0524_107_251_20180906_00340.jpg

Looking northwest at the waterside slope.

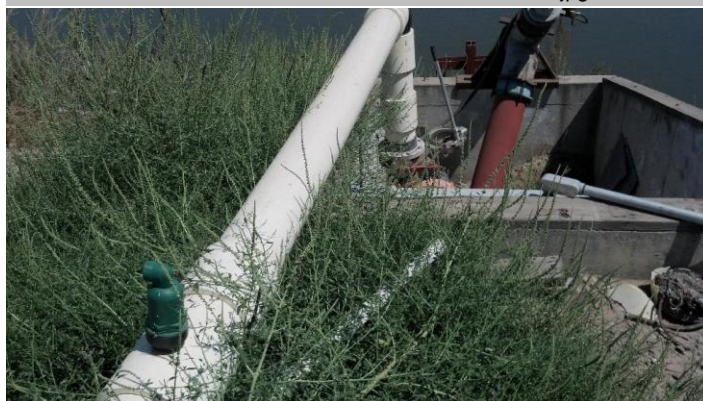
Photo 2 of 3 : UCIP_FA_2018_22725_38444.jpg

Vent on PVC pipe at WS shoulder.

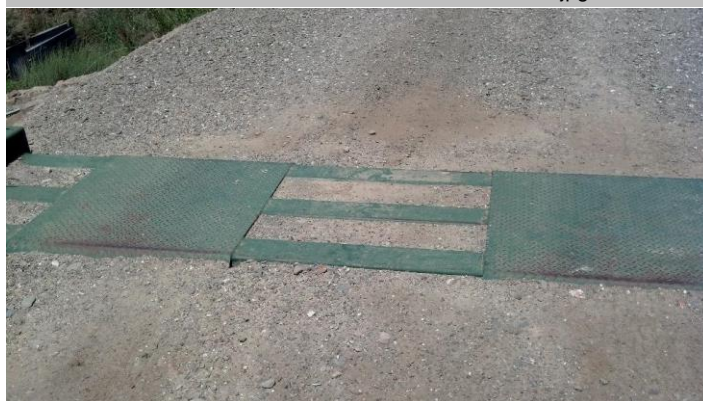
Photo 3 of 3 : UCIP_FA_2018_22725_38443.jpg

Steel, integrated cattle guard style pipe crossing at crown elevation.

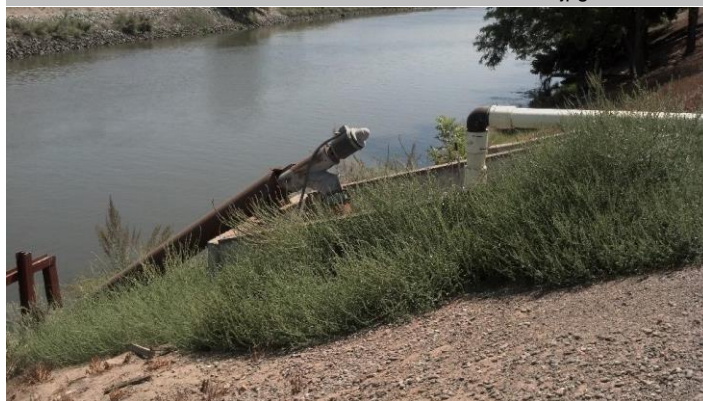
Photo 1 of 3 : UCIP_FA_2018_18307_30528.jpg

Slant pump visible at concrete foundation on WS slope. Pumphouse removed.

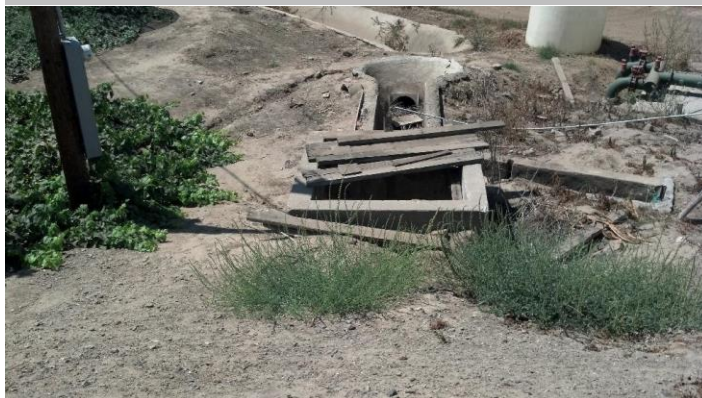
Photo 3 of 3 : UCIP_FA_2018_18307_30526.jpg

6'X6' concrete distribution box and power pole on LS toe.

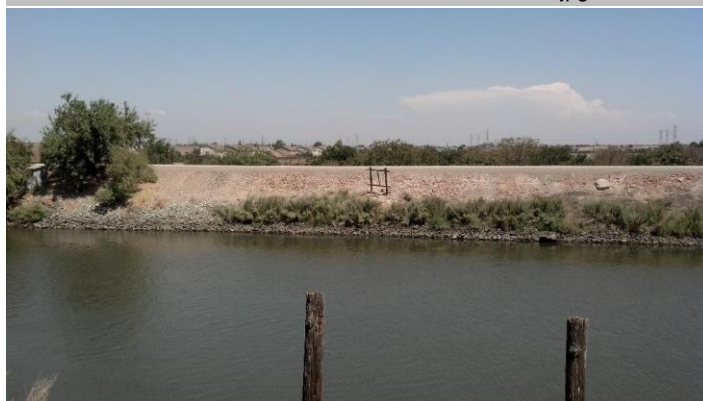
Photo 2 of 2 : UCIP_FA_2018_41464_30542.jpg

Sign posts visible on opposite river bank in same condition.

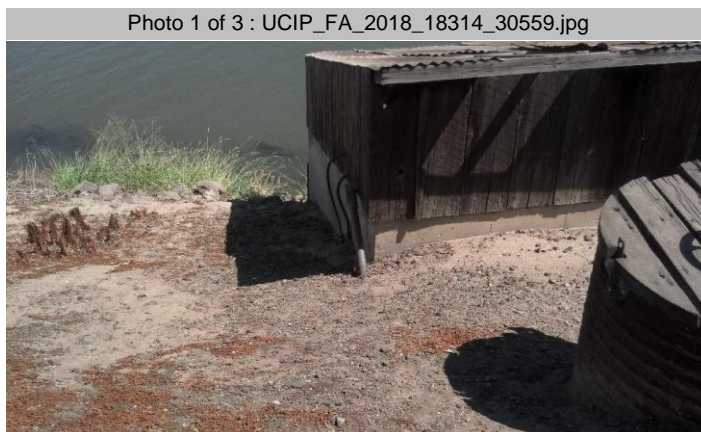
Comment Code					
Inspector Comment					
FS_ID:18314 DS_ID:20623 EP_NO: N/A Repair Type: Non-Urgent Crossing Status: Found UCIP Comments: Appears abandoned and if so should be done so properly. FIELD_STRUCT_DESC: 8-inch concrete encased steel irrigation pipe through the levee, 9.5 feet below the crown. Pump and gate valve in pump house on the waterside (WS) slope. Slide gate in 42-inch corrugated metal pipe riser unit on the WS slope. Brick standpipe at the toe of the landside (LS) slope. 1.5-inch galvanized iron electrical conduit through the levee, 3 feet below the crown at the same location. [Additional Reference(s): DWR Levee Log, 2004. USACE San Joaquin O&M Manual 7, April 1964, (HLM 4.08)]. FS Date: 8/20/2013

Electrical conduit visible on WS slope at pumphouse.

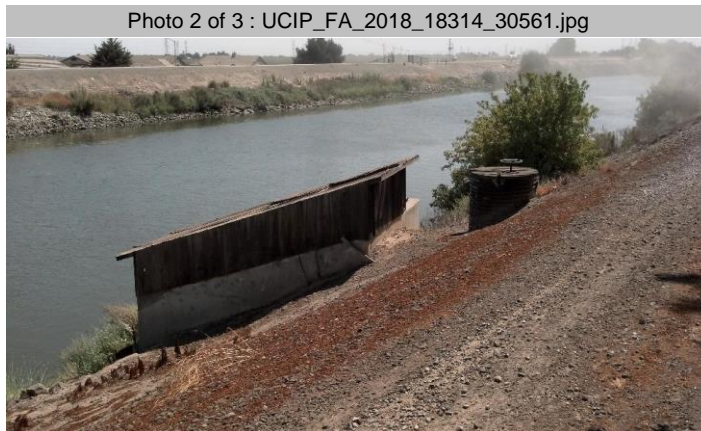
Pumphouse and gate valve in CMP riser on WS slope.

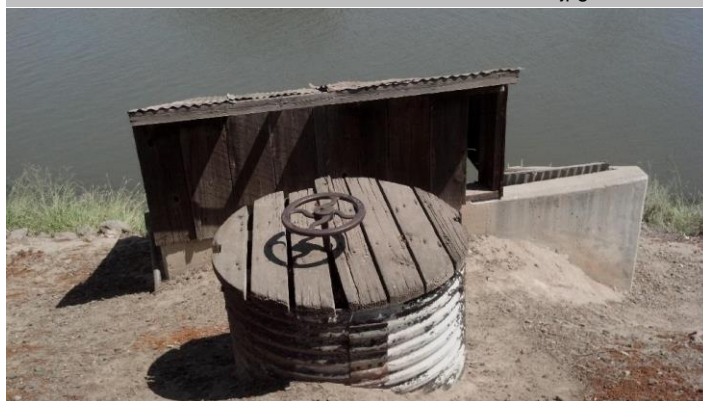
Photo 3 of 3 : UCIP_FA_2018_18314_30560.jpg

Pumphouse and gate valve in CMP riser on WS slope.

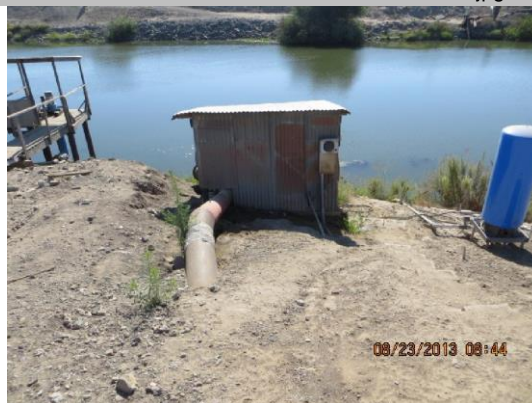
Photo 3 of 3 : UCIP_FA_2018_18318_30587.jpg

Pumphouse and pipe on WS slope.

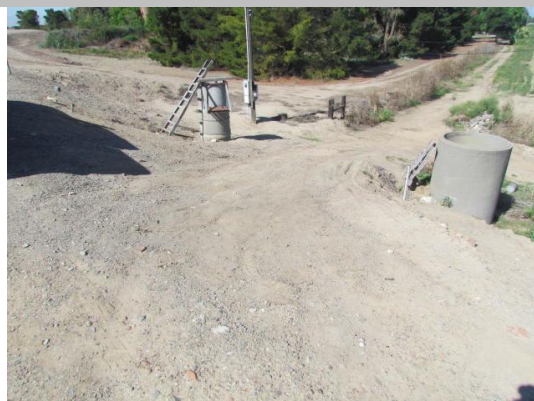
Photo 1 of 1 : FA_2018_RD0524_107_110_20180906_00173.jpg

Looking southwest at an unauthorized ramp on landside slope.

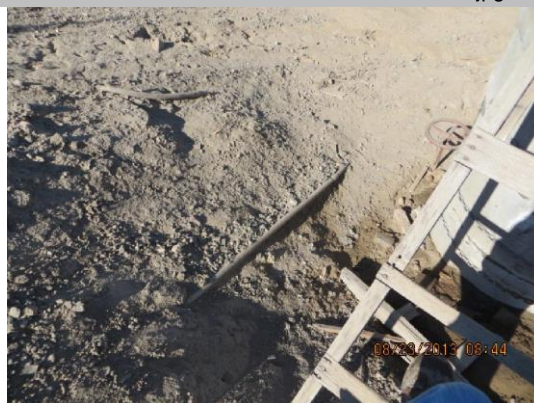
Photo 1 of 2 : UCIP_FA_2018_22069_37660.jpg

Pipe visible on LS slope.

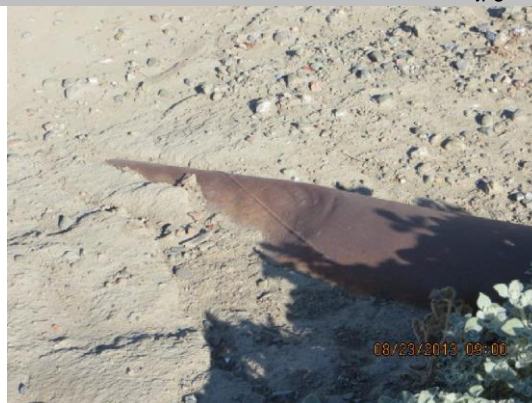
Photo 3 of 3 : UCIP_FA_2018_18320_30592.jpg

Pipe partially crushed at LS toe.

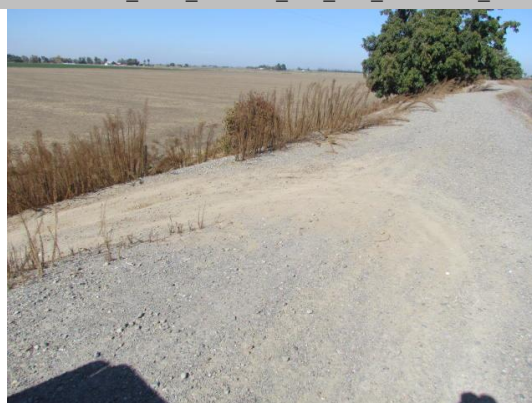
Photo 1 of 1 : FA_2018_RD0524_107_115_20180906_00180.jpg

Looking northwest at slope damage on landward slope.

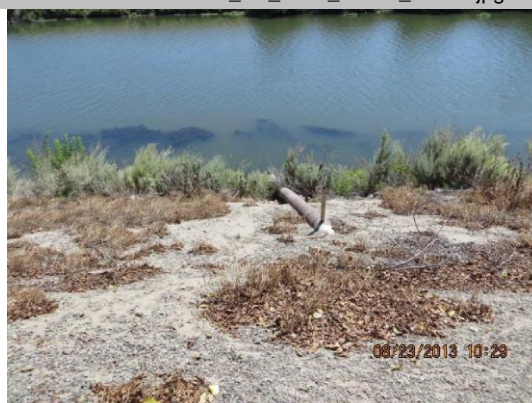
Photo 1 of 3 : UCIP_FA_2018_53358_30689.jpg

Pipe visible on WS slope.

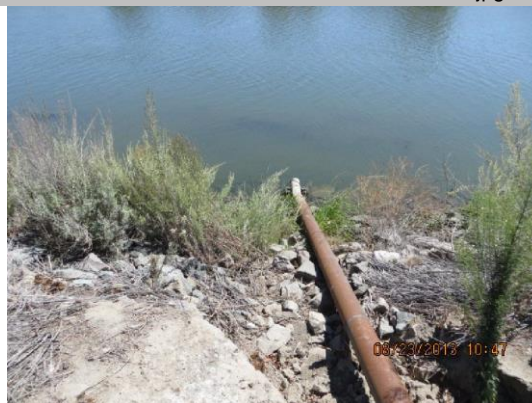
Photo 3 of 3 : UCIP_FA_2018_18348_30704.jpg

No flap gate on end of pipe at WS toe.

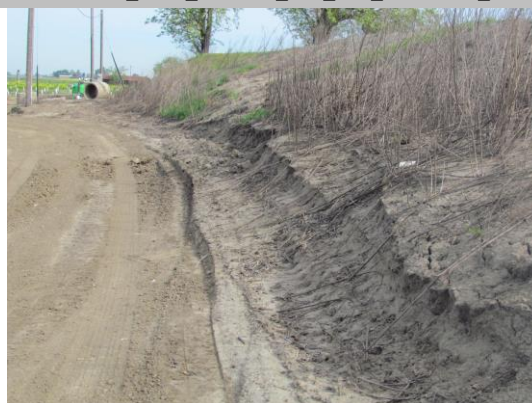
Photo 2 of 2 : FA_2018_RD0524_107_166_20180906_00217.jpg

Looking at north at damage to landward toe.

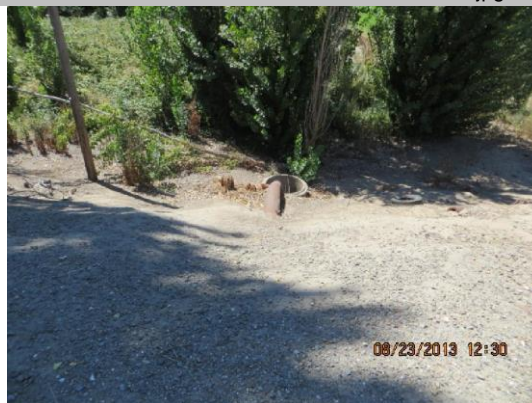
Photo 2 of 2 : UCIP_FA_2018_18392_30909.jpg

Pipe and concrete standpipe visible on LS toe.
